Manhole Inspection Summary

Manhole # S37S__046MH

Insp Date: 2/20/08 10:39 AM

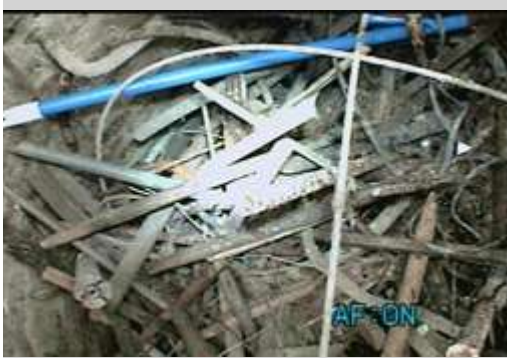
Defect 1

Condition: ☐ Sound ☐ Cracked ☐ Root Intrusion ☐ Deteriorated ☐ Leaks ☒ **Debris**

DEBRIS

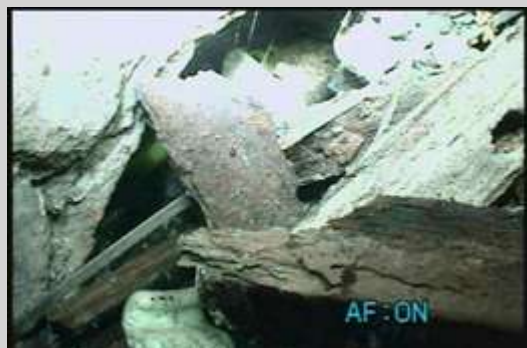
12 O'Clock Outflow

Deposits: ☐ None ☐ Mud ☐ Sludge ☒ **Debris** ☐ Grease

Silt Depth: **6** (in.) Deposits Extent: **Heavy**
